# Manhole Inspection Summary

Manhole # S33YY\_005MH

**Location** Address: **3120 SAINT PAUL ST**

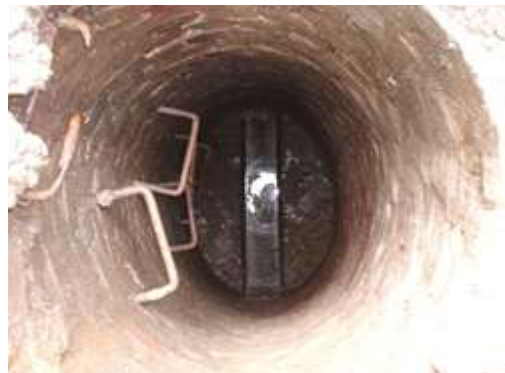
Top View

Corroded and missing steps. Evidence of surcharge - Bench debris. Channel debris.

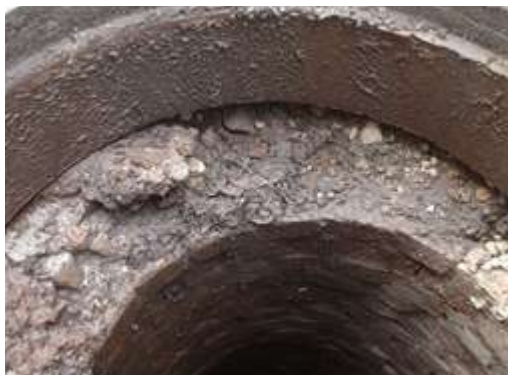
Defect

Frame leaks. Frame offset. Adjustment deterioration and infiltration.

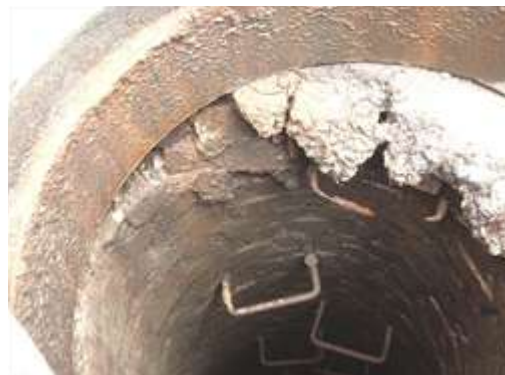
Defect

Frame leaks. Frame offset. Adjustment deterioration and infiltration.

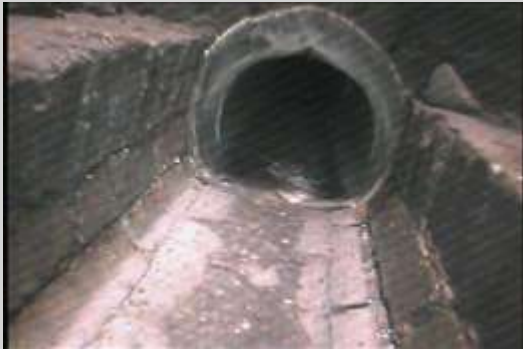
### 10 in. Circular Gravity Sewer Pipe Out @ 12 O'Clock

Channel deterioration.

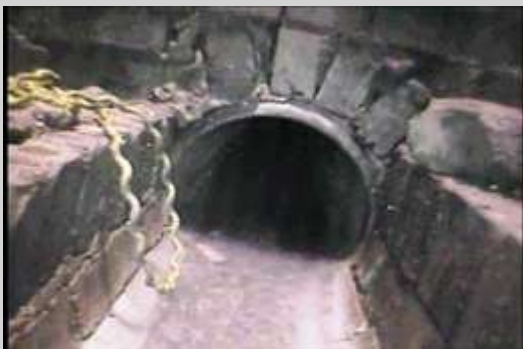
### 10 in. Circular Gravity Sewer Pipe In @ 6 O'Clock

Barrel deterioration and infiltration.
